AEROSTAR CONTINUED
AIRWORTHINESS INSTRUCTIONS
FOR
AEROSTAR (RAVEN) HOT AIR BALLOONS

ACAI
PART II

Type Certificate No. A15CE

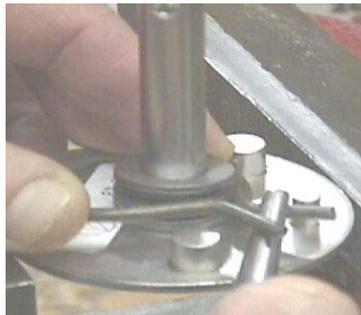
Photo 6.2.13b

- (H) Using a tapered drift tool, twist the right leg of the spring past the left leg and over the small center pin while holding the spring flat against the plate with the other hand. (See photo 6.2.13b)

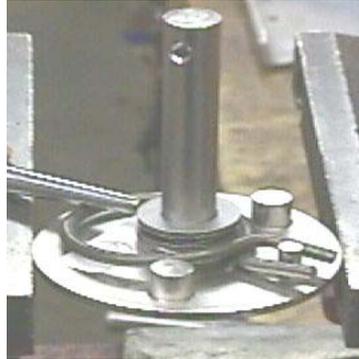
Photo 6.2.13c

Tap the legs down securely over the small center pin (while still holding the spring against the plate). Then tap the legs of the spring towards the center of the plate so that the legs do not overlap past the plate edge, while holding the spring down to the plate with a tapered punch or similar tool. (See photo 6.2.13c)
